Report, Puncture Resistance Testing, 6 and 9 Mar 2012

Executive Summary

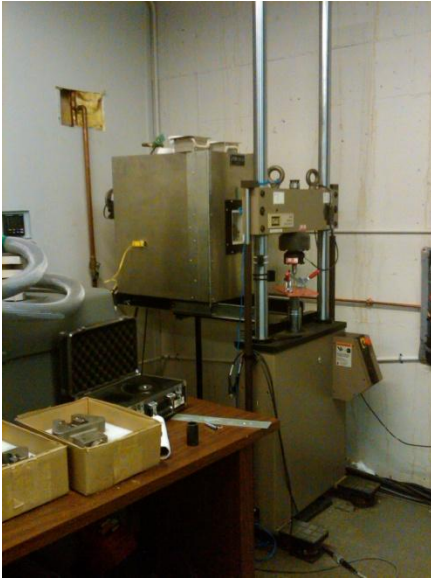
Figure 1: The MTS 810 Hydraulic Test Frame

The test probe and specimen test fixture were constructed IAW ASTM 2412-5 specifications by an engineer at the CAPE Lab. The test probe and fixture were all designed to fit the test device: the MTS 810 system, the load frame, its related hydraulics, and computerized controls.

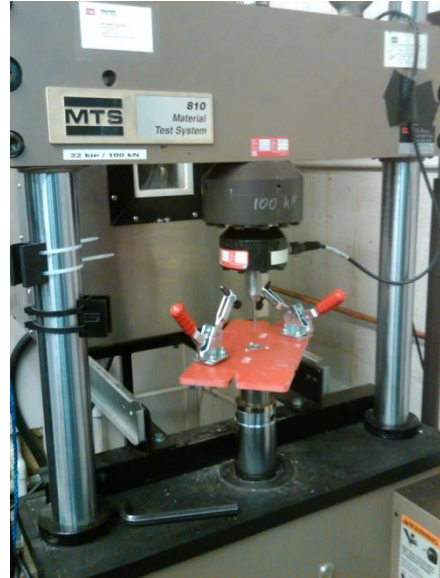
Figure 2: The test fixture, on which the test specimen is mounted

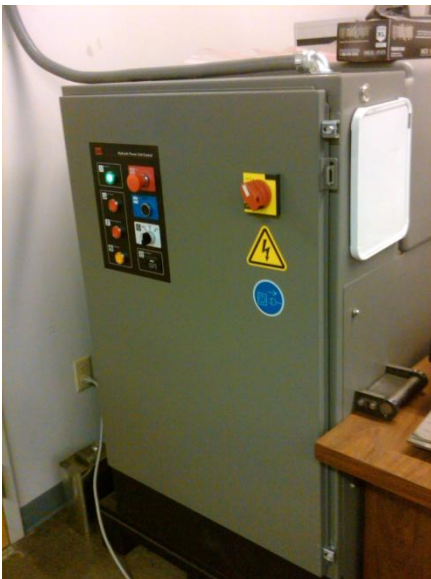
Figure 3: The Hydraulics Controller

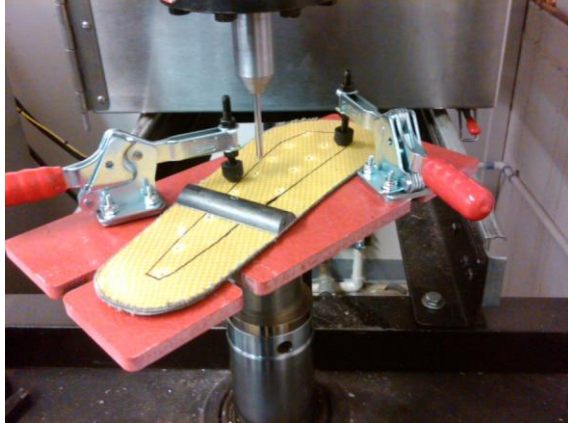
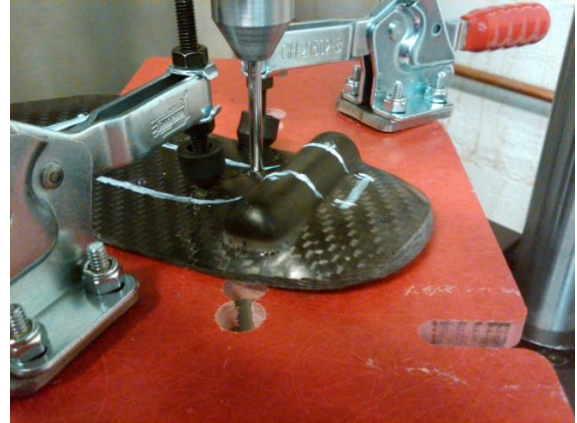
Figure 5: The Spring Plate, locked onto the test fixture, with several trials completed

Figure 6: The Heel Cradle, locked onto the test fixture, with several trials completed

As shown in Figures 5 and 6, the test specimens were mounted in the MTS 810 test fixture and puncture testing on the specimens was conducted. Each hole in the specimen represents a penetration trial. The area outlined in black on the Spring Plates and in white on the Heel Cradles represents the area prescribed by the ASTM in which testing may be conducted. This testing was called Part 1 testing. Part 2 testing consisted of penetration trial outside the marked areas, and within the one inch margin from the specimens' edges.

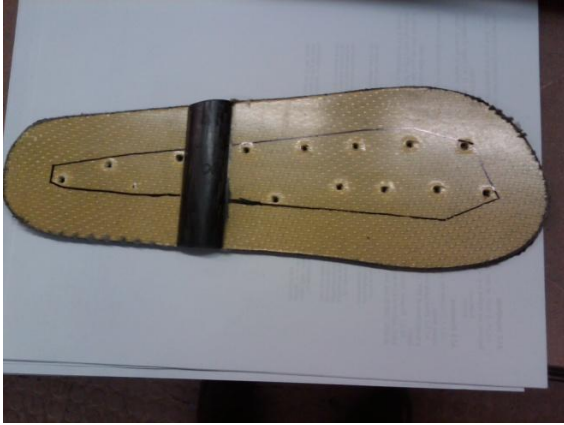
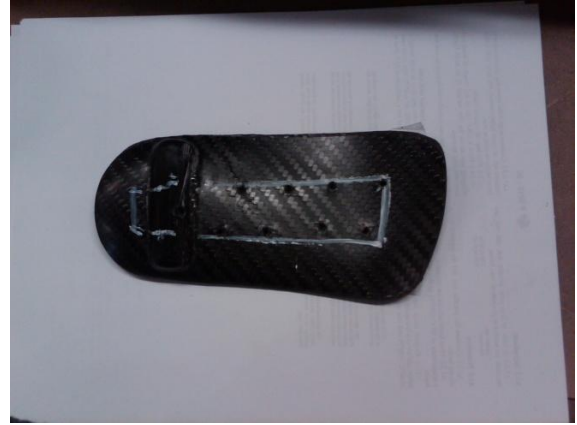
Figures 7 and 8 show test specimens with the penetration trials completed.

Figure 7: The Spring Plate

Figure 8: The Heel Cradle

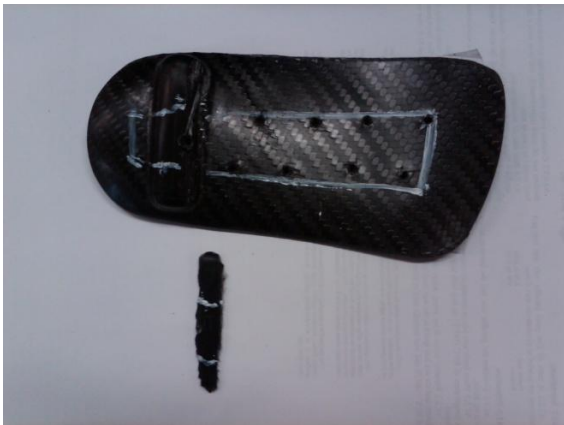
Figure 9: A sliver has broken off the fulcrum as a result of the penetration trial

During the testing process, it was observed that the test probe was jeopardized when applied against the fulcrums of both the Spring Plate and the Heel Cradle. In the case of the Spring Plate fulcrum, the test probe had difficulty finding purchase on the smooth, rounded surface. The concern was that the probe would slip off the fulcrum's surface and either bend or break. In the case of the Heel Cradle, the probe was able to penetrate the fulcrum, but, in one case, the fulcrum split off a fragment of the fulcrum. In a second trial, the fulcrum was completely split off the Heel Cradle.

The test narrative reported issues with testing the fulcrums on both the Spring Plates and on the Heel Cradles. Specifically, the fulcrums either broke in pieces or broke completely off the test specimen. Figures 9 and 10 serve to document these issues on the Heel Cradles.

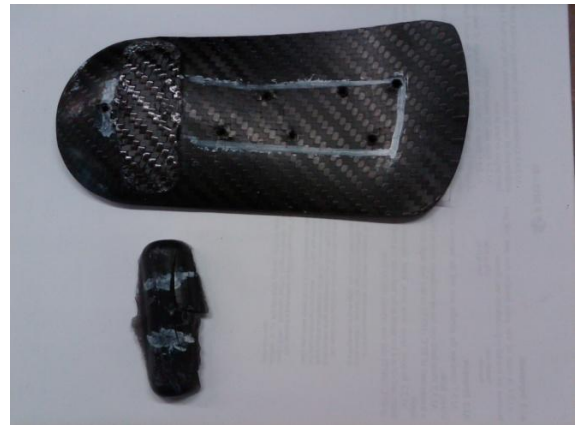
Figure 10: The fulcrum has separated from the Heel Cradle completely

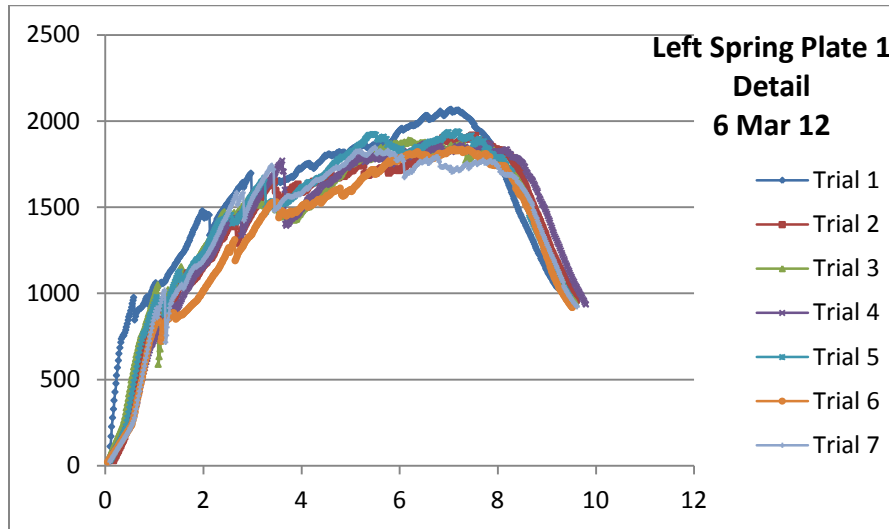
As reported in the test narrative, the computerized test protocol identically reproduced the penetration trials repeatedly. A detailed data set was generated for each penetration trial. Figures 12 and 13 are representative samples of the detailed data set.

Figure 12: Exemplar detailed penetration trials 1 through 7 on a left Spring Plate (Sport Model)

Figure 13: Exemplar detailed penetration trials 8 through 14 on a left Spring Plate (Sport Model)

Two sets of graphs can be developed and analyzed using the data recorded by the instrumentation. The first set is the detailed track of the probe, measured by applied force (in Newtons) and by the amount of probe extension (in mm). The peak of the graph represents the "minimum force required for penetration to occur". The second set of data is the cumulative recording of "minimum force required", by specimen penetration trial. The second set of data may best be described as a summary of all the penetration trials made on each specimen.

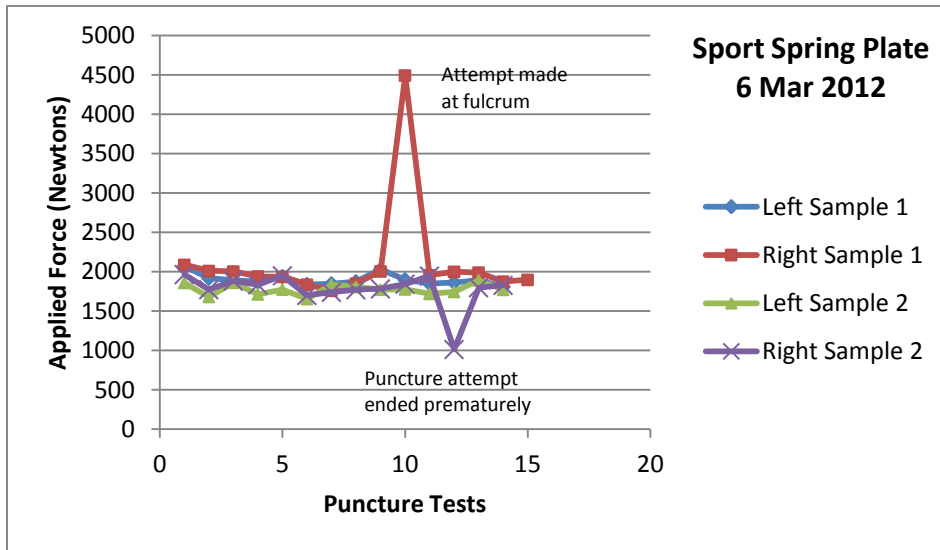
Additionally, a summary data set was generated for each specimen, capturing the “minimum force necessary” to puncture the specimen. Figures 14 through 16 are examples of the summarized penetration trial results, including Spring Plates, Heel Cradles, and Boot Sole Assemblies.

Figure 14: Example Summary Chart, Spring Plate penetration trials

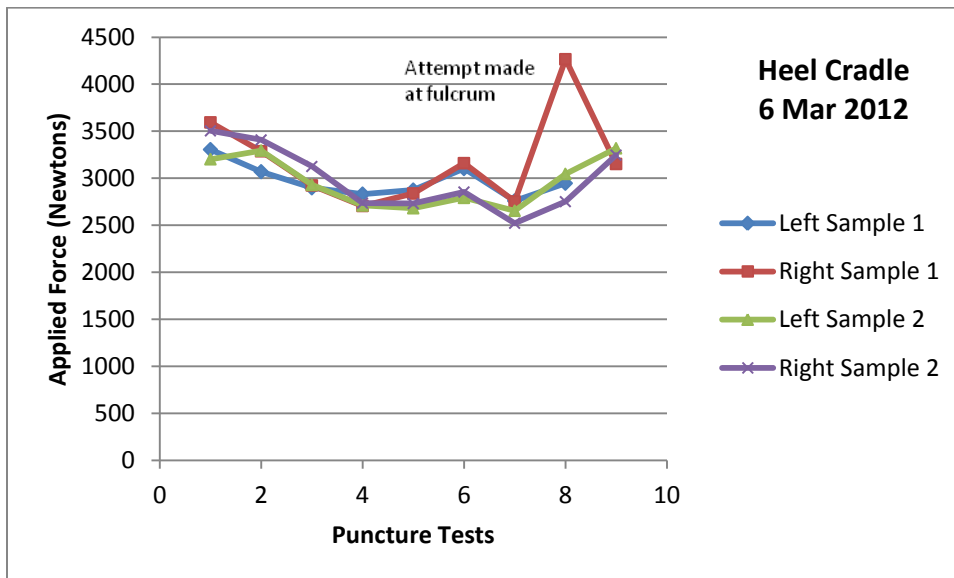
Figure 15: Example Summary Chart, Heel Cradle penetration trials

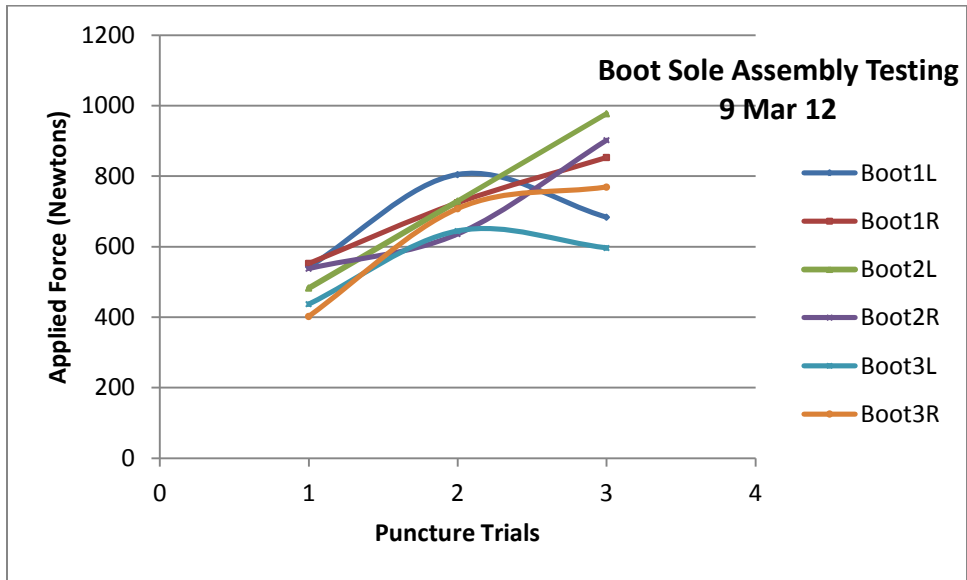
The boot sole assemblies were tested in the same manner as the Kingetics orthotics, using the same testing protocols and equipment.

Figure 16: Example Summary Chart, Boot Sole Assembly penetration trials

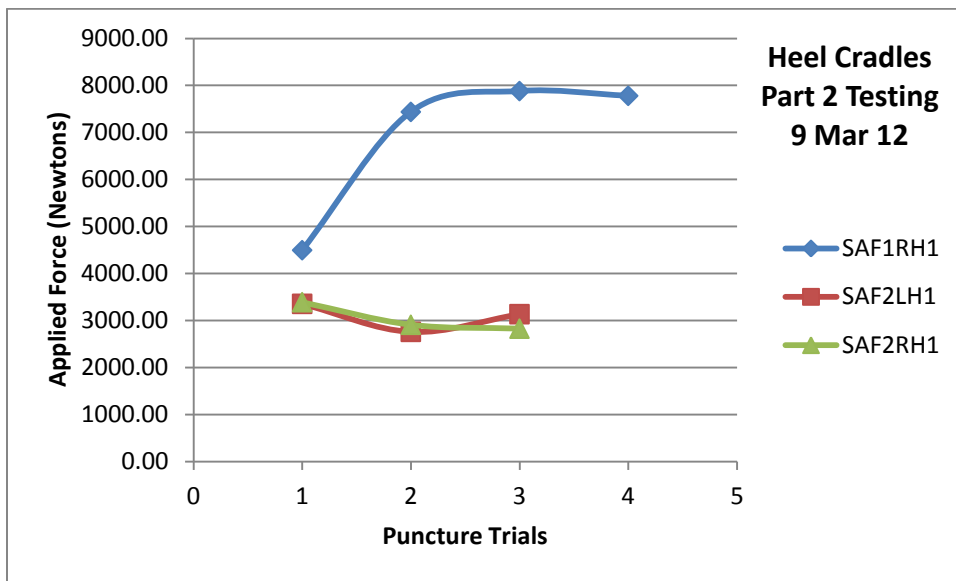
Figure 17 documents what is believed to be an error in sample marking. The specimen labeled “SAF1RH1” is the only penetration trial of a Safety Model Heel Cradle made before cancelling further testing of the Safety Model Heel Cradles to preclude damage to the test probe. The specimens marked “SAF2LH1” and “SAF2RH1”, respectively, are actually Sport Model Heel Cradle Part 2 penetration trials, and were incorrectly marked prior to the testing. This marking error will be corrected in future testing. The data itself is deemed to be correct for a Sport Model Heel Cradle.

Figure 17: Example Summary Chart, Heel Cradle, Part 2 penetration trials

Additionally, a summary data set was generated for each specimen, capturing the “minimum force necessary” to puncture the specimen. Figures 17 through 18 are examples of the summarized Part 2 penetration trial results, including Spring Plates and Heel Cradles.

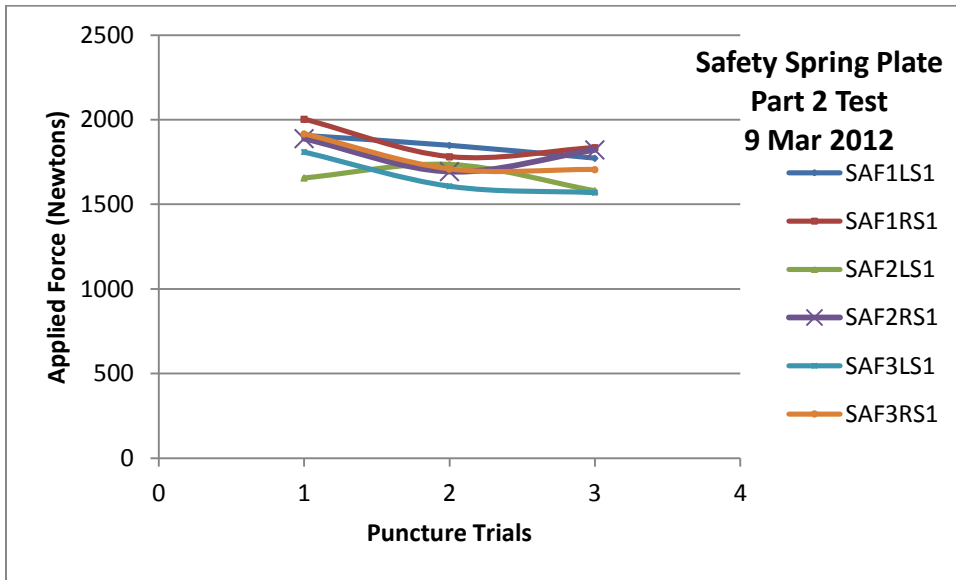
Figure 18: Example Summary Chart, Spring Plate Part 2 penetration trials
